### Removing Efflorescence and Soil from the Surface of Concrete Pavers

LANXESS Deutschland GmbH  
Business Unit  
Inorganic Pigments  
D-51369 Leverkusen

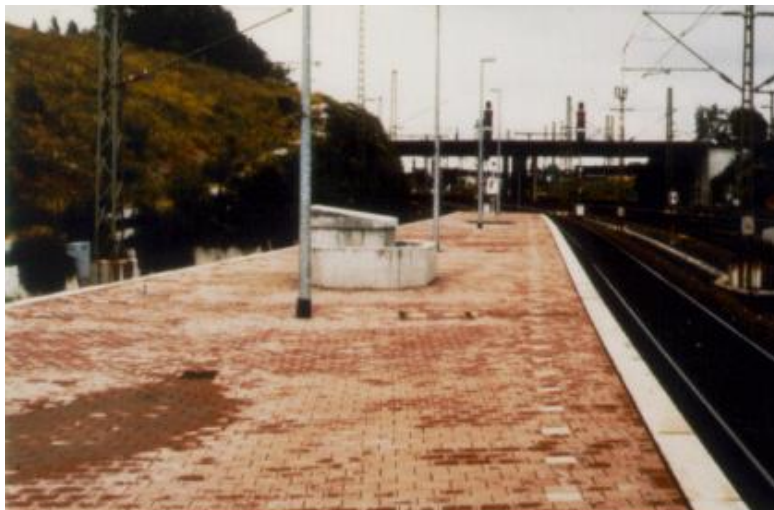
**Picture 1**

shows the platform of a railway station with red concrete pavers on which heavy efflorescence has formed.

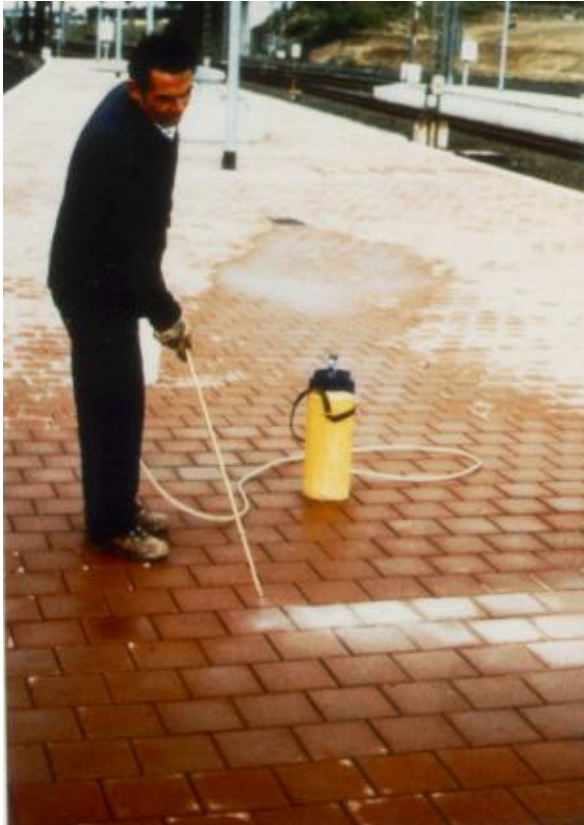
**Picture 2**

The paver surfaces, wetted with water, are carefully sprayed with dilute acid applying low pressure. What should be avoided is treating too large a surface in one operation: the contact with the acid would be too long and the attack on the paver surface stronger than desired.

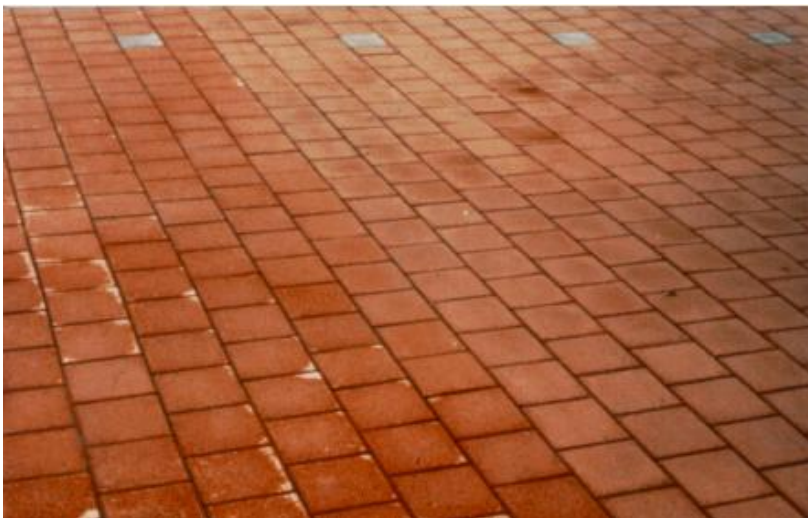
**Picture 3  
(Detail of Picture 2)**

All the pavers you see are wet. It is obvious that those on the left-hand side have been acid-treated (the red is much deeper) whereas those on the right-hand side (paler color shade) are waiting for the treatment.

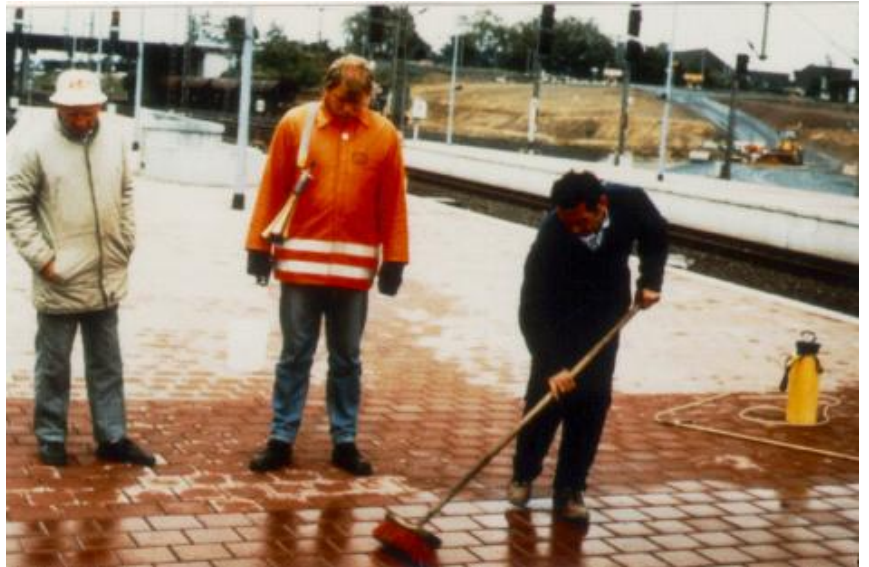
**Picture 4**

The dilute acid is distributed with a broom to allow it to act homogeneously.

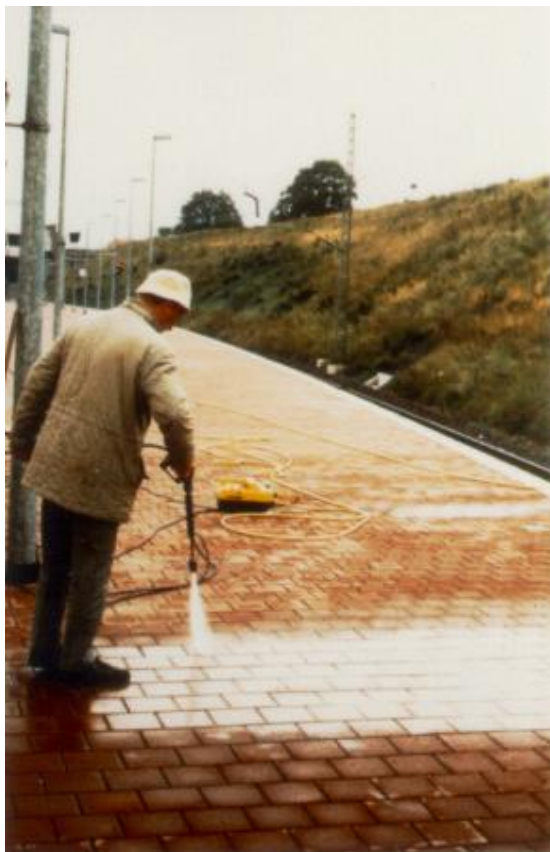
**Picture 5**

After the acid has acted for a short time, the concrete pavers are thoroughly rinsed with clear water (here with the help of a high-pressure cleaner).

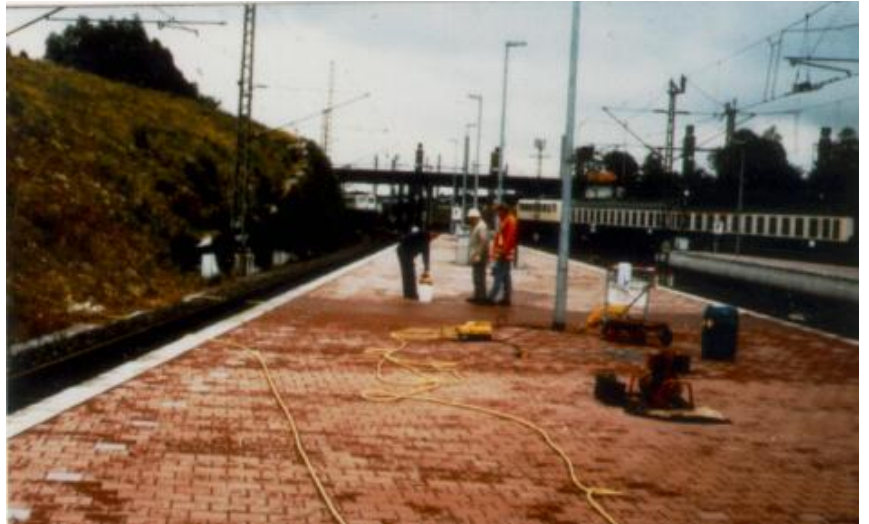
**Picture 6**

shows the same platform. The pavers in the foreground have already undergone the acid treatment; they have just been rinsed with water and are not yet completely dry. The strip of pavers in front of the three workers is being treated. The untreated pavers behind the workers show the same heavy efflorescence as illustrated by Picture 1.

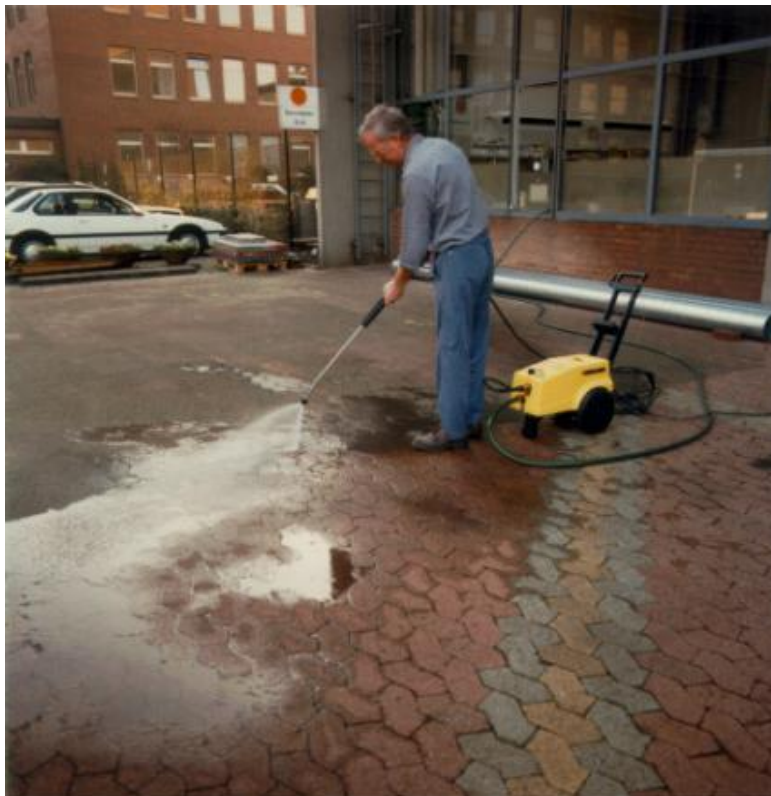
The rinsing with water alone using a high-pressure cleaner permits removing dirt from the paver surface. **Picture 7** shows a very dirty concrete surface which has partly been cleaned (foreground): the original color shades are showing up.

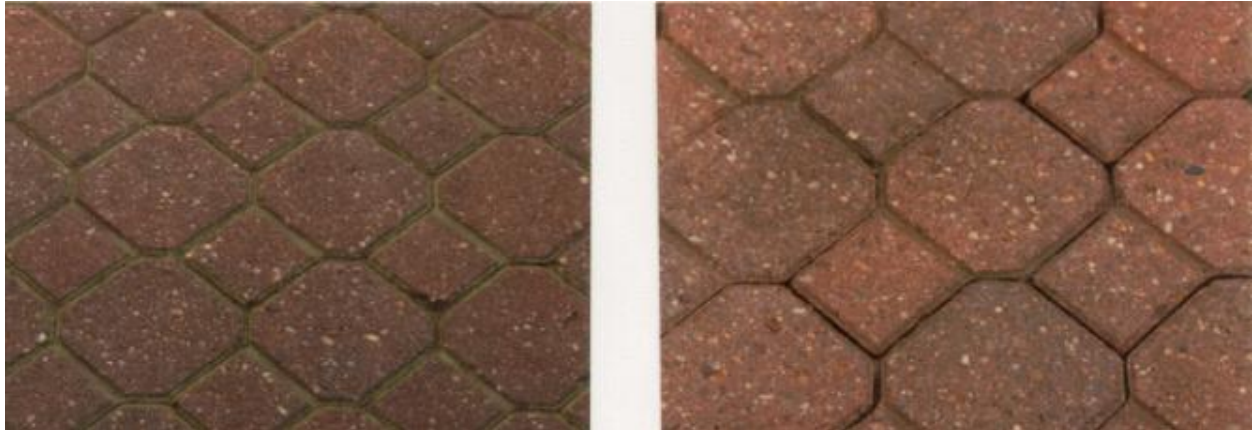
Also algae, moss etc. can be removed, as shown by **Picture 8** (before the treatment) and **Picture 9** (after treating the concrete surface with a high-pressure cleaner).

Possible drawback of high pressure cleaning: joints that are washed out must be refilled with sand.
